Subject: Department of Natural Resources Washington Geological Survey,
School Seismic Safety Assessment Project, Contract No. AE 410 -
Seismic Evaluation for **Green Mountain School District**

School Buildings Evaluated in the Green Mountain School District

1. Green Mountain School, Gymnasium
2. Green Mountain School, Main Building

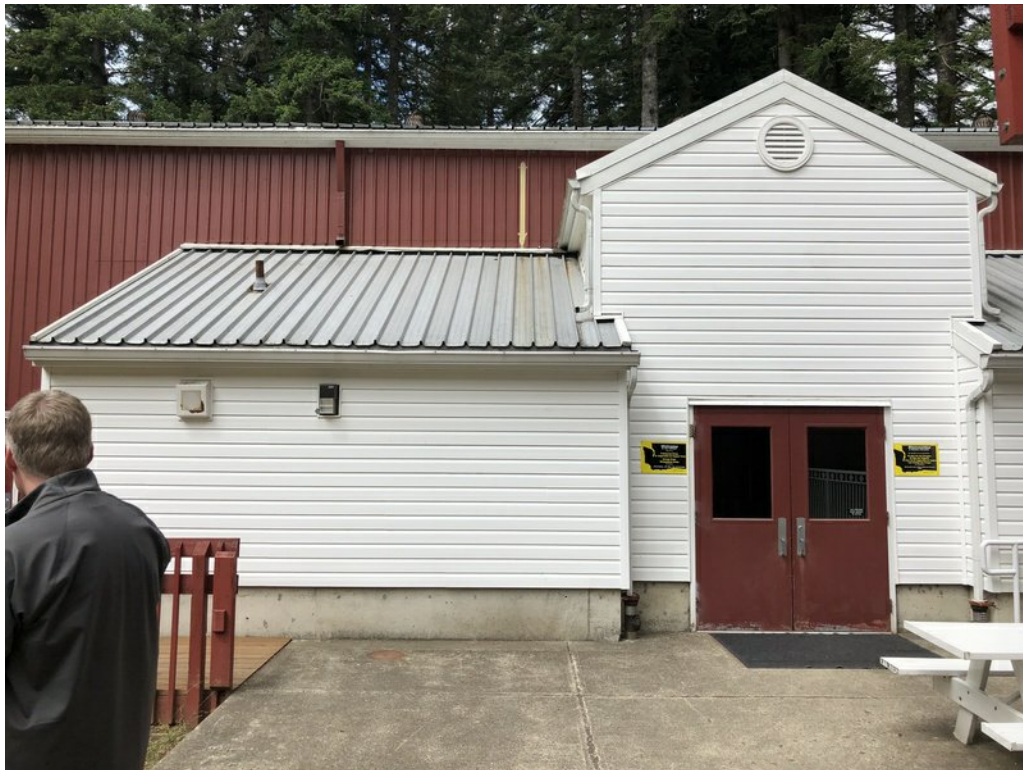
Figure 1-1. Green Mountain Gymnasium - East Entrance

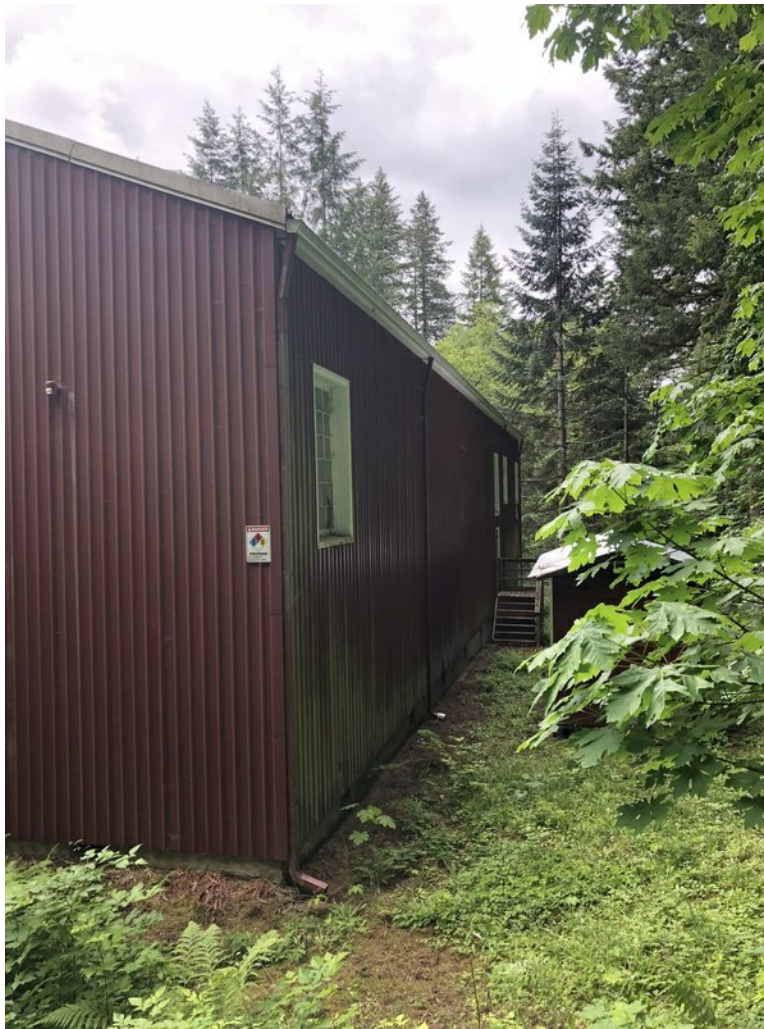
Figure 1-2. Green Mountain Gymnasium - Northwest Exterior

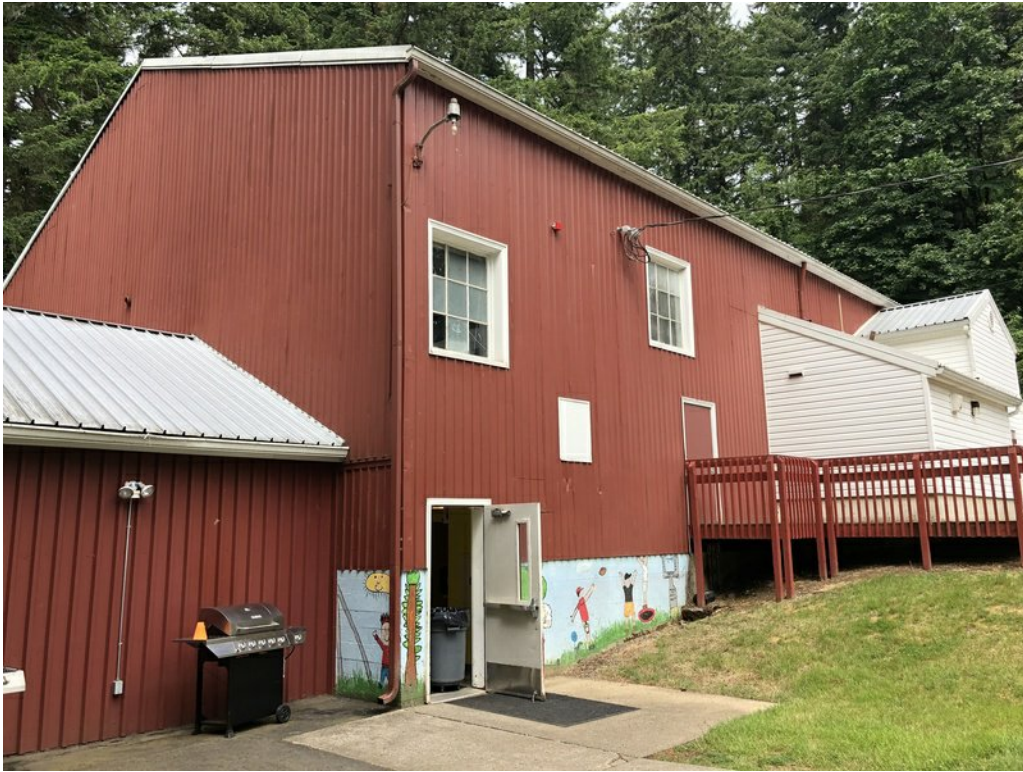
Figure 1-3. Green Mountain Gymnasium - Southeast Exterior

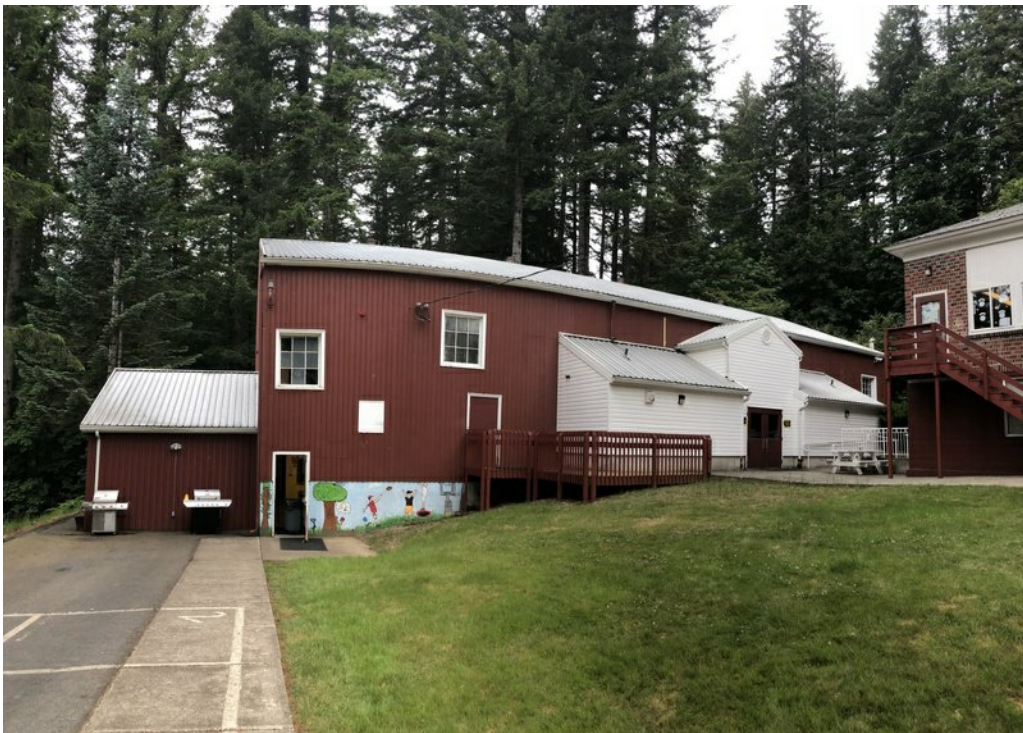
Figure 1-4. Green Mountain Gymnasium - East Exterior

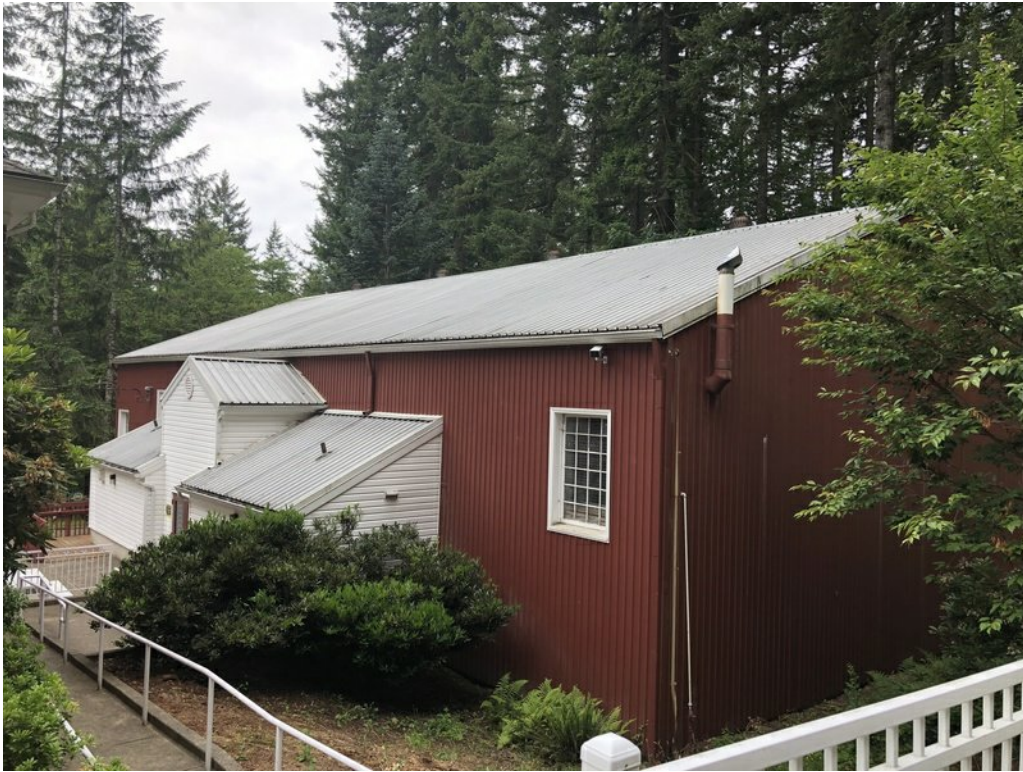
Figure 1-5. Green Mountain Gymnasium - Northeast Exterior

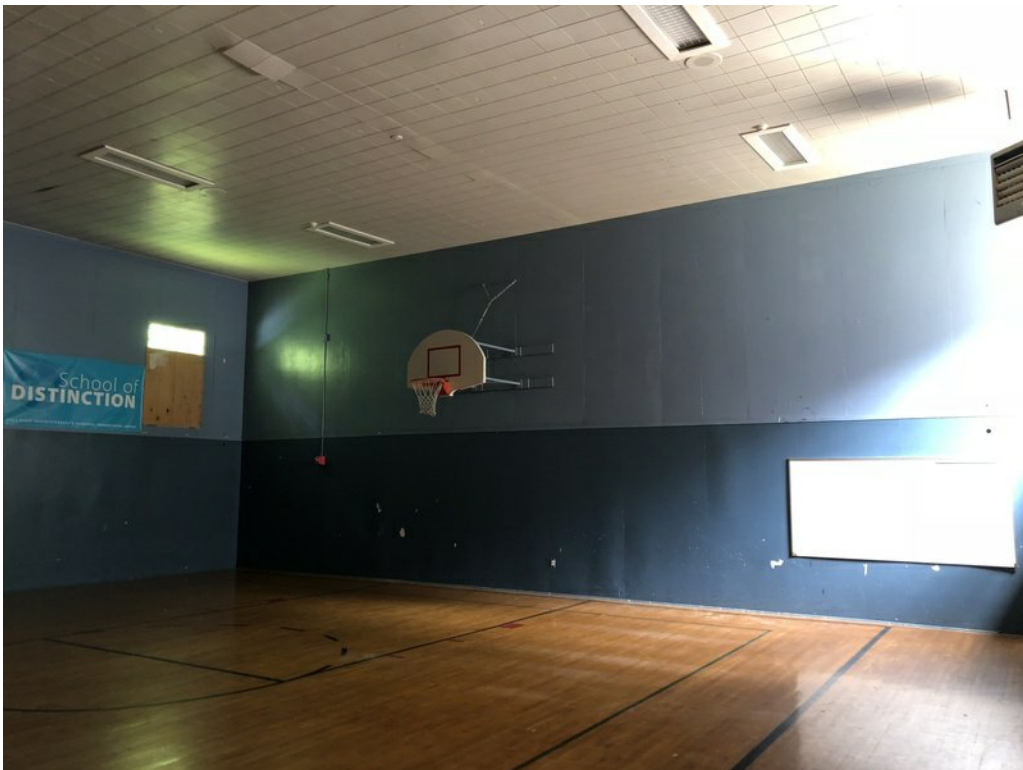
Figure 1-6. Gymnasium

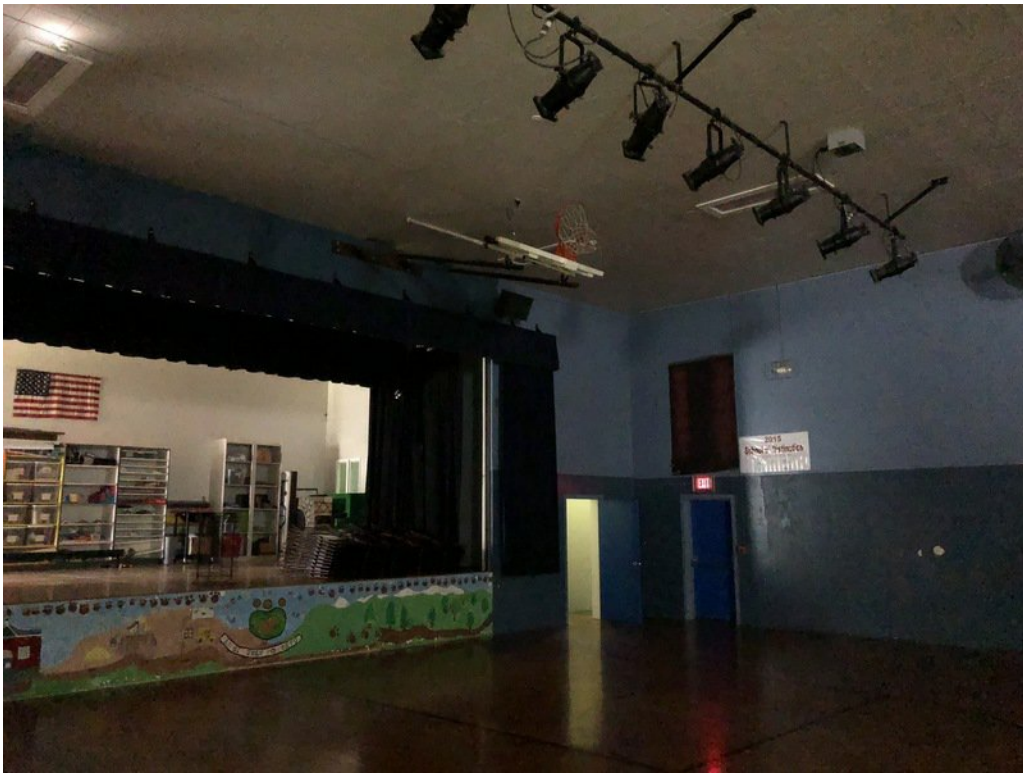
Figure 1-7. Stage

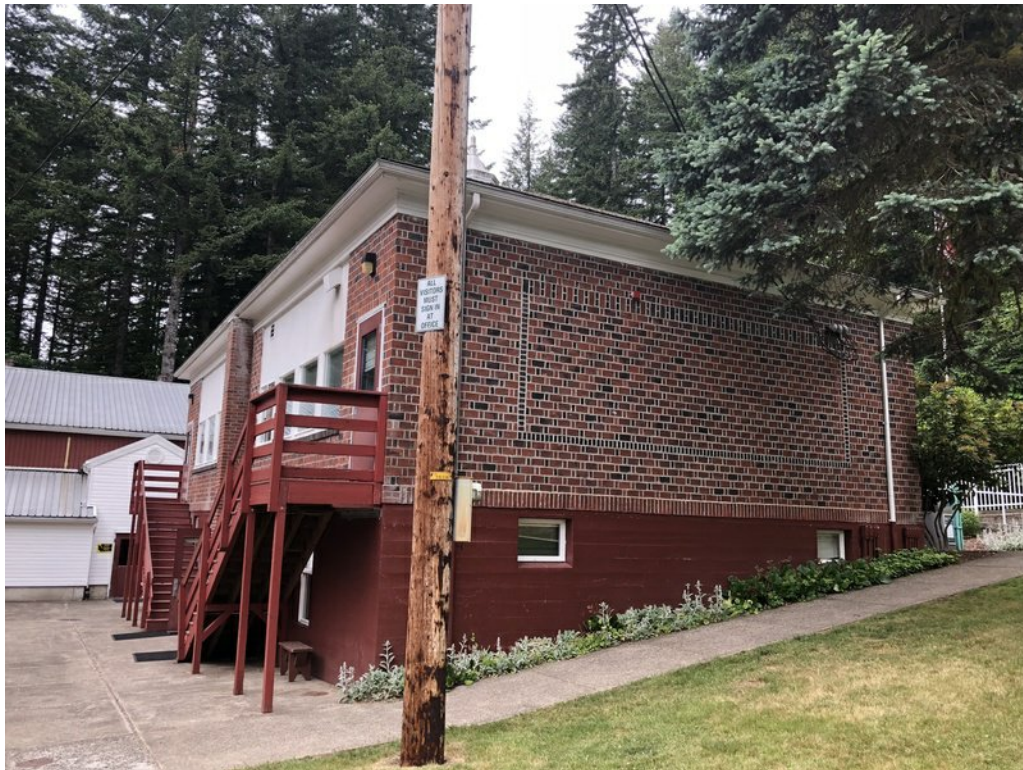
Figure 1-1. Green Mountain School - East Exterior

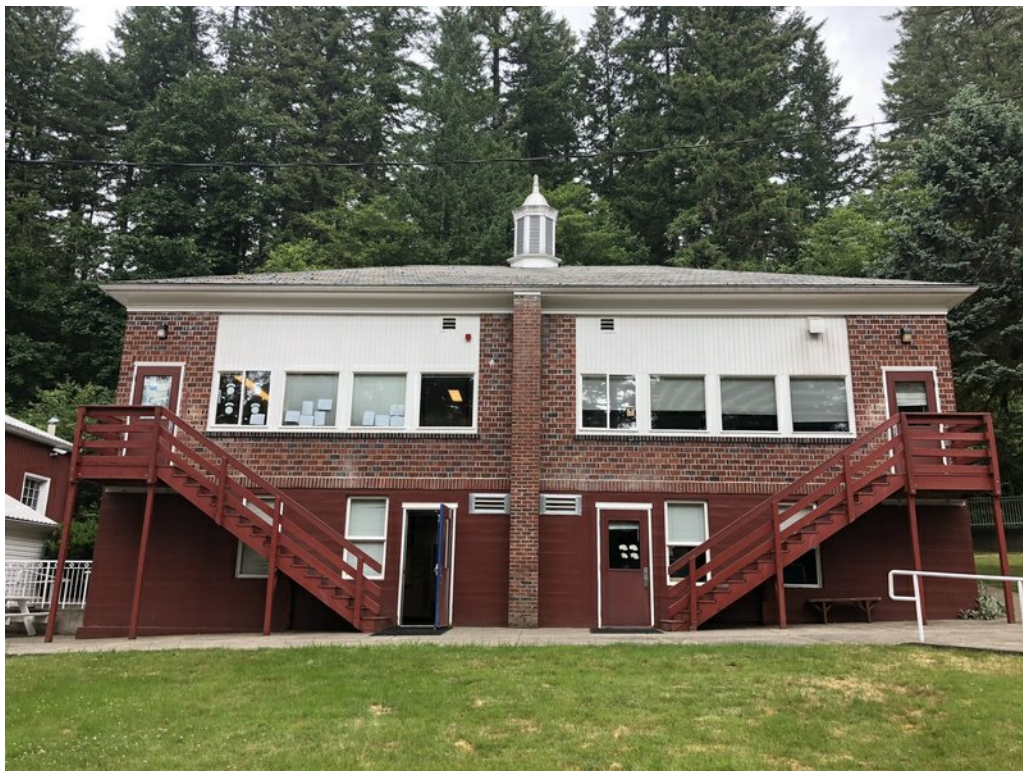
Figure 1-2. Green Mountain School - South Exterior

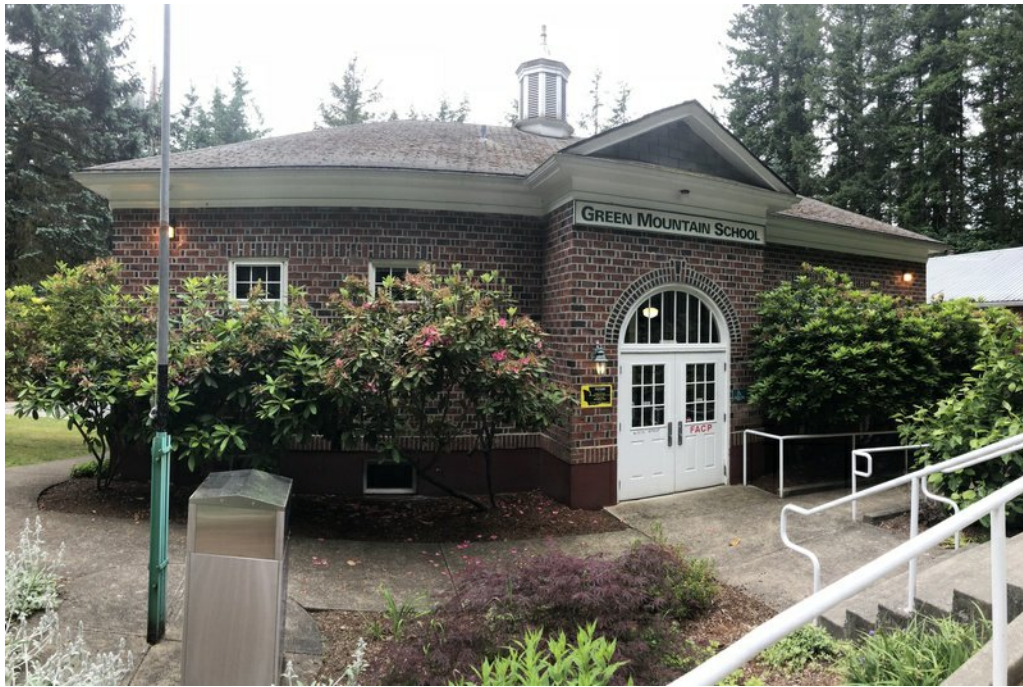
Figure 1-3. Green Mountain School - North Exterior

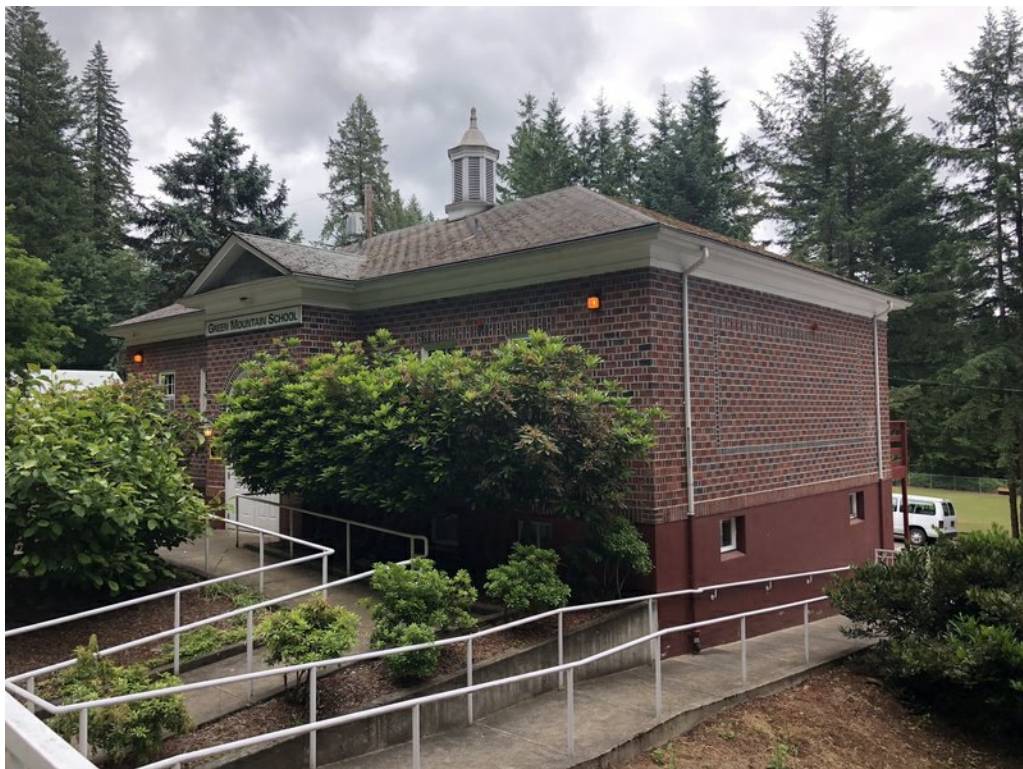
Figure 1-4. Green Mountain School - West Exterior

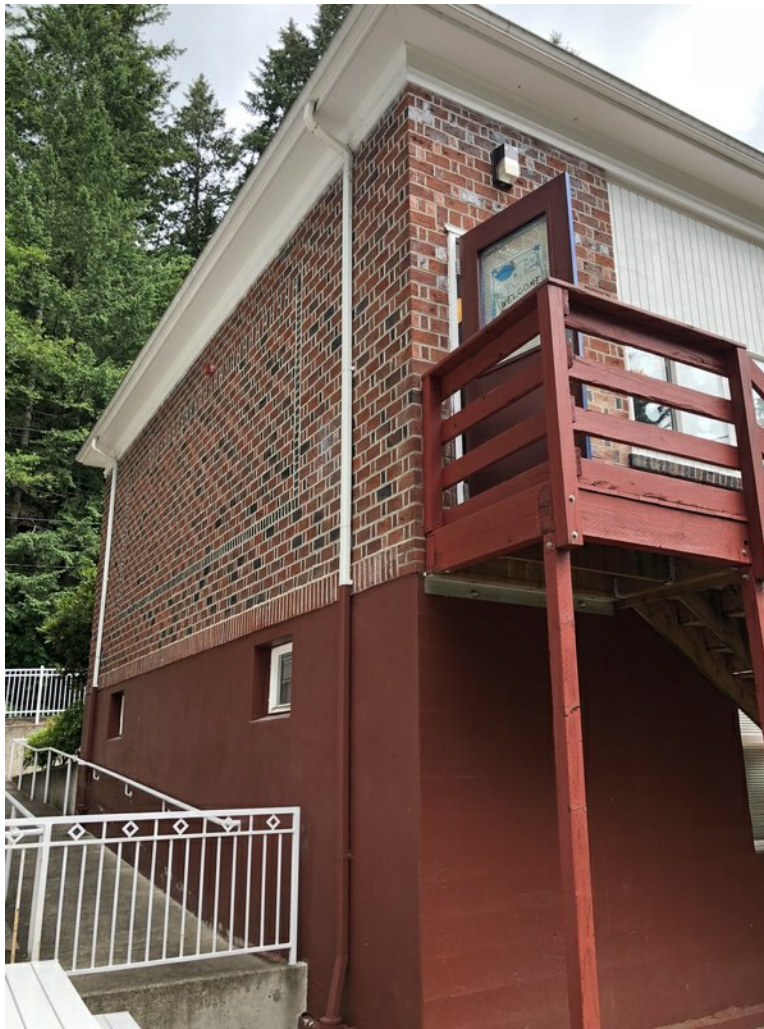
Figure 1-5. Wood-Framed Balcony at South Exterior

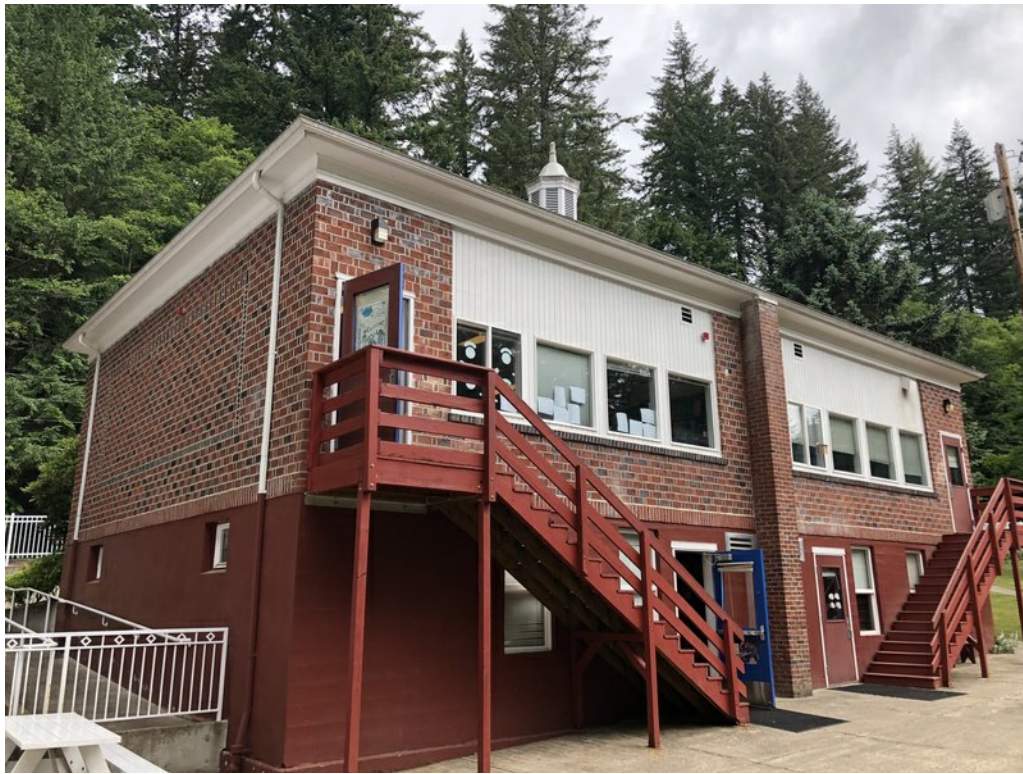
Figure 1-6. Green Mountain School - Southwest Exterior

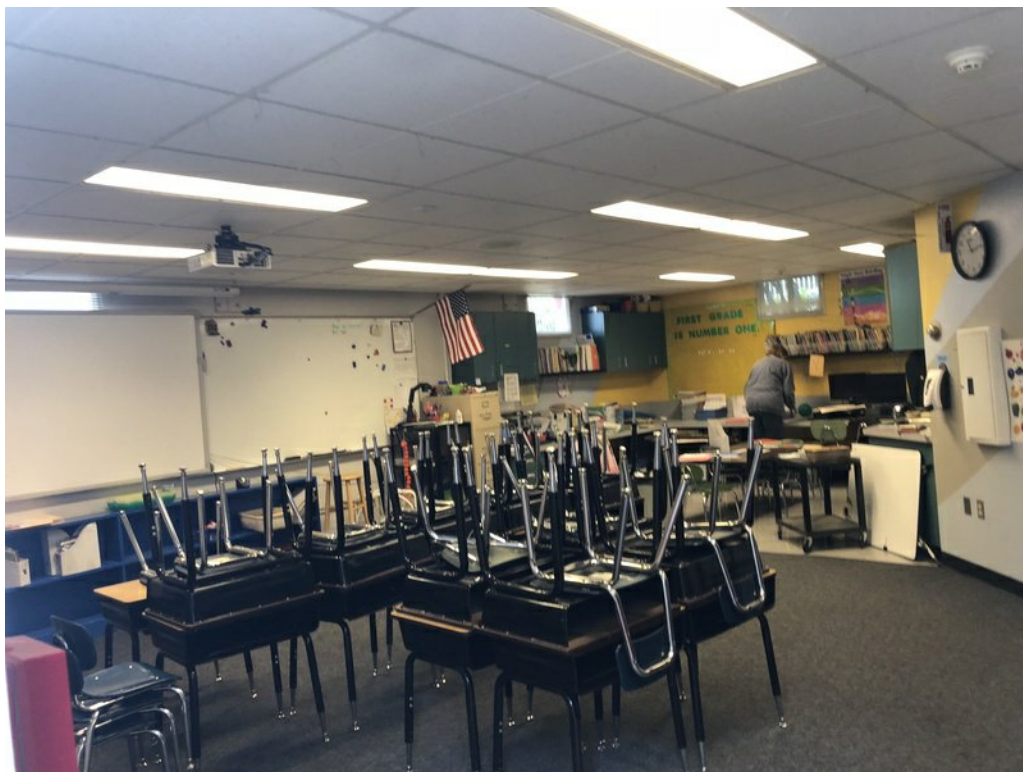
Figure 1-7. Typical Classroom with Unknown Light Fixture Bracing

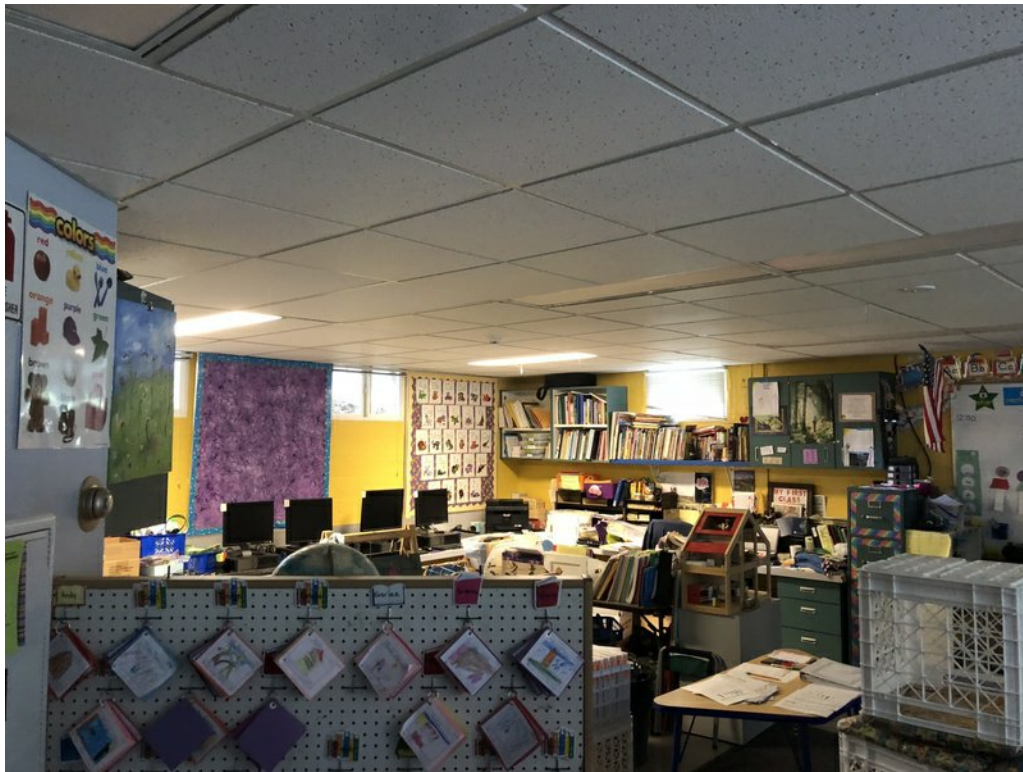
Figure 1-8. Computer Room with Unknown Light Fixture Bracing

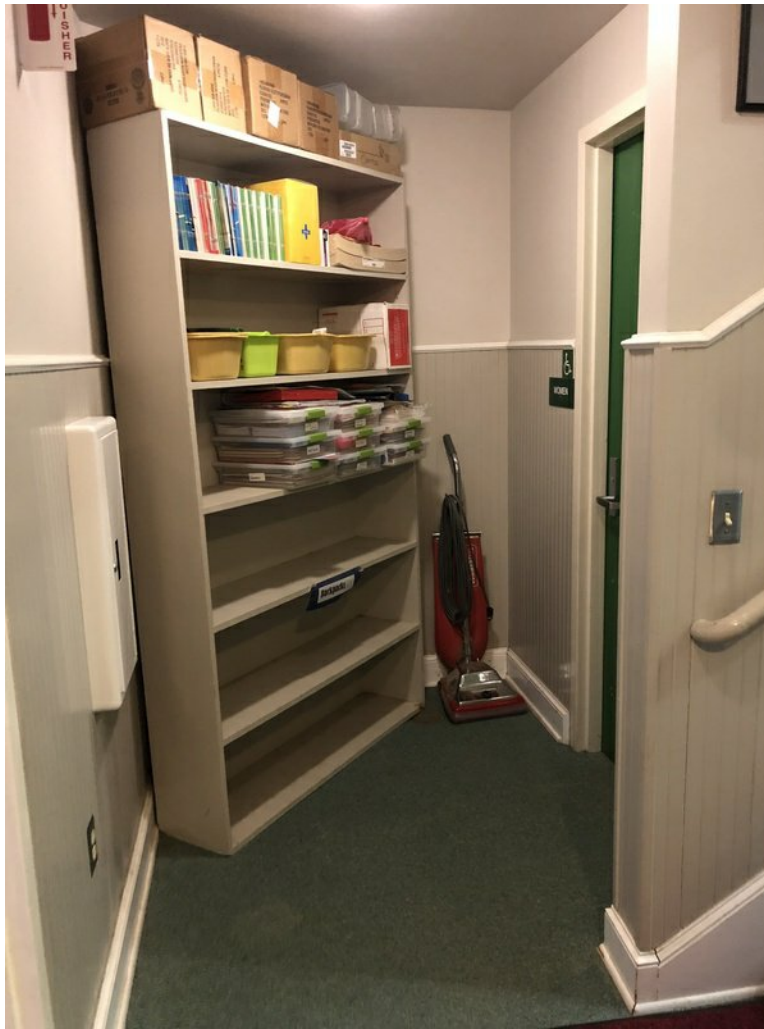
Figure 1-9. Tall Nonstructural Components Unbraced, Typical Throughout

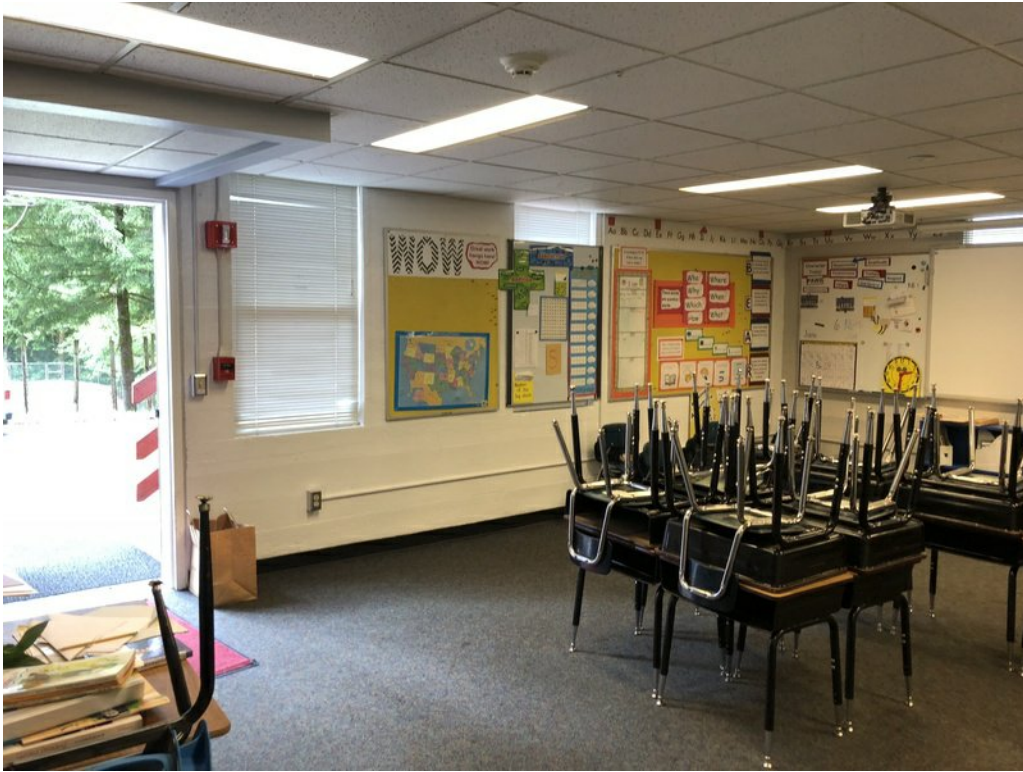
Figure 1-10. Classroom - South Interior
